**East Fork Little Sandy
Stream Restoration Project
Lawrence County, Kentucky**

Sections 404/401 Clean Water Act
(CWA) Permit Application

SECTIONS 404/401 CLEAN WATER ACT (CWA) PERMIT APPLICATION
OUTLINE

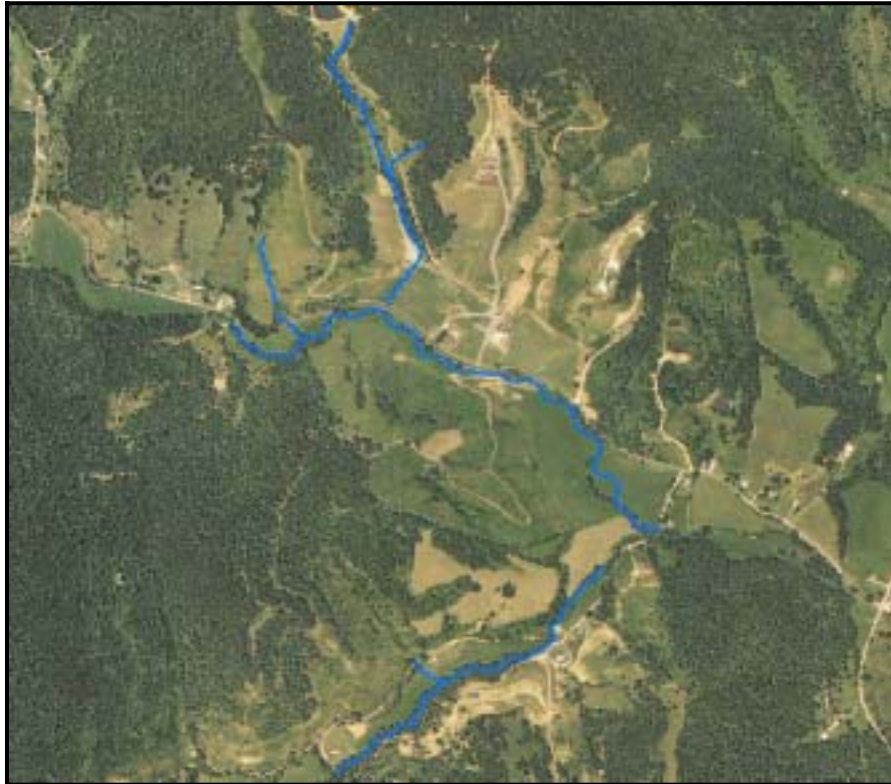
Figure 1.4 Aerial Photography of East Fork Little Sandy Stream Restoration Project

Figure 1.4 was obtained from aerial photography provided by the National Agriculture Imagery Program. The photograph was taken in the spring of 2006. The blue lines show the project extents for East Fork Little Sandy Stream Restoration Project.

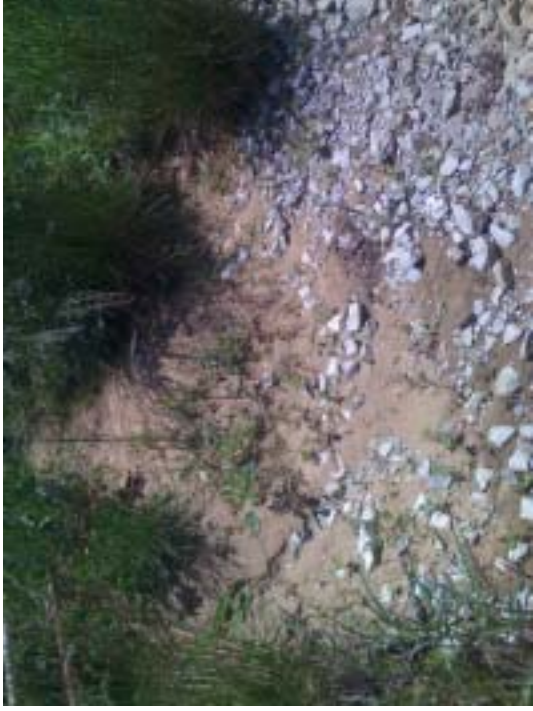
A photograph showing a close-up view of the stream bed, which is composed of numerous small, light-colored rocks and pebbles. The water is shallow and clear, revealing the underlying stones.	Photo 2. East Fork Little Sandy 5/27/08

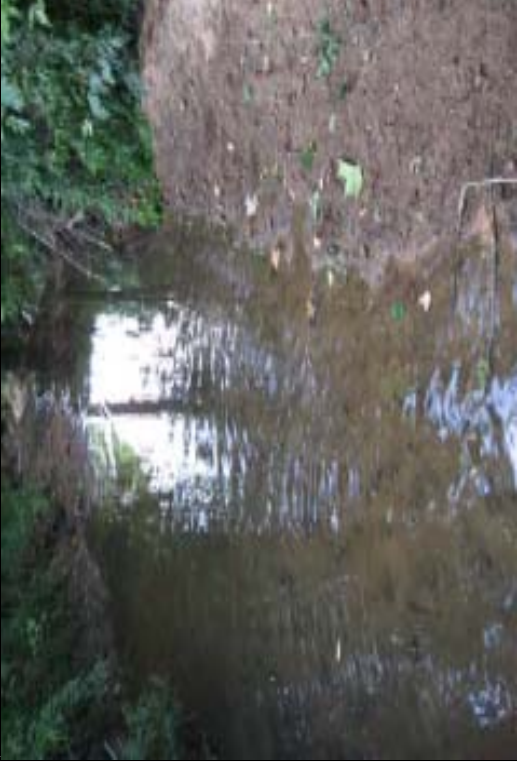
Photograph

Assessment Objectives: Determined Habitat Quality of Impacted Reach

Measure	Units
1. Epifaunal Substrate	8	(0-20)
2. Embeddedness	13	(0-20)
3. Velocity/Depth Regime	18	(0-20)
4. Sediment Deposition	8	(0-20)
5. Channel Flow Status	8	(0-20)
6. Channel Alteration	8	(0-20)
7. Freq. Of Riffles (bends)	8	(0-20)
8. Bank stability (both combined)	8	(0-20)
9. Veg. Protection (both combined)	14	(0-20)
10. Riparian Width (both combined)	4	(0-20)

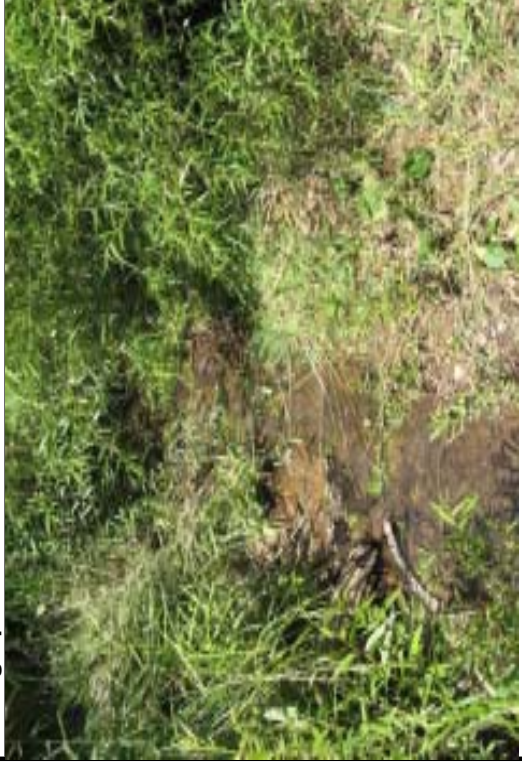
Photograph

Assessment Objectives: Determined Habitat Quality of Impacted Reach

RBP Habitat Parameters	Measure	Units
1. Epifaunal Substrate	8	(0-20)
2. Embeddedness	3	(0-20)
3. Velocity/Depth Regime	18	(0-20)
4. Sediment Deposition	8	(0-20)
5. Channel Flow Status	8	(0-20)
6. Channel Alteration	8	(0-20)
7. Freq. Of Riffles (bends)	8	(0-20)
8. Bank stability (both combined)	2	(0-20)
9. Veg. Protection (both combined)	14	(0-20)
10. Riparian Width (both combined)	4	(0-20)
Total Habitat Score	81

Habitat Integrity Index	Subindex
	0.10
